**LIGHTNING AND STATIC ELECTRICITY
CONFERENCE, 3-5 DECEMBER 1968**

PART II. CONFERENCE PAPERS

TECHNICAL REPORT AFAL-TR-68-290, PART II

AIR FORCE AVIONICS LABORATORY
AIR FORCE SYSTEMS COMMAND
WRIGHT-PATTERSON AIR FORCE BASE, OHIO

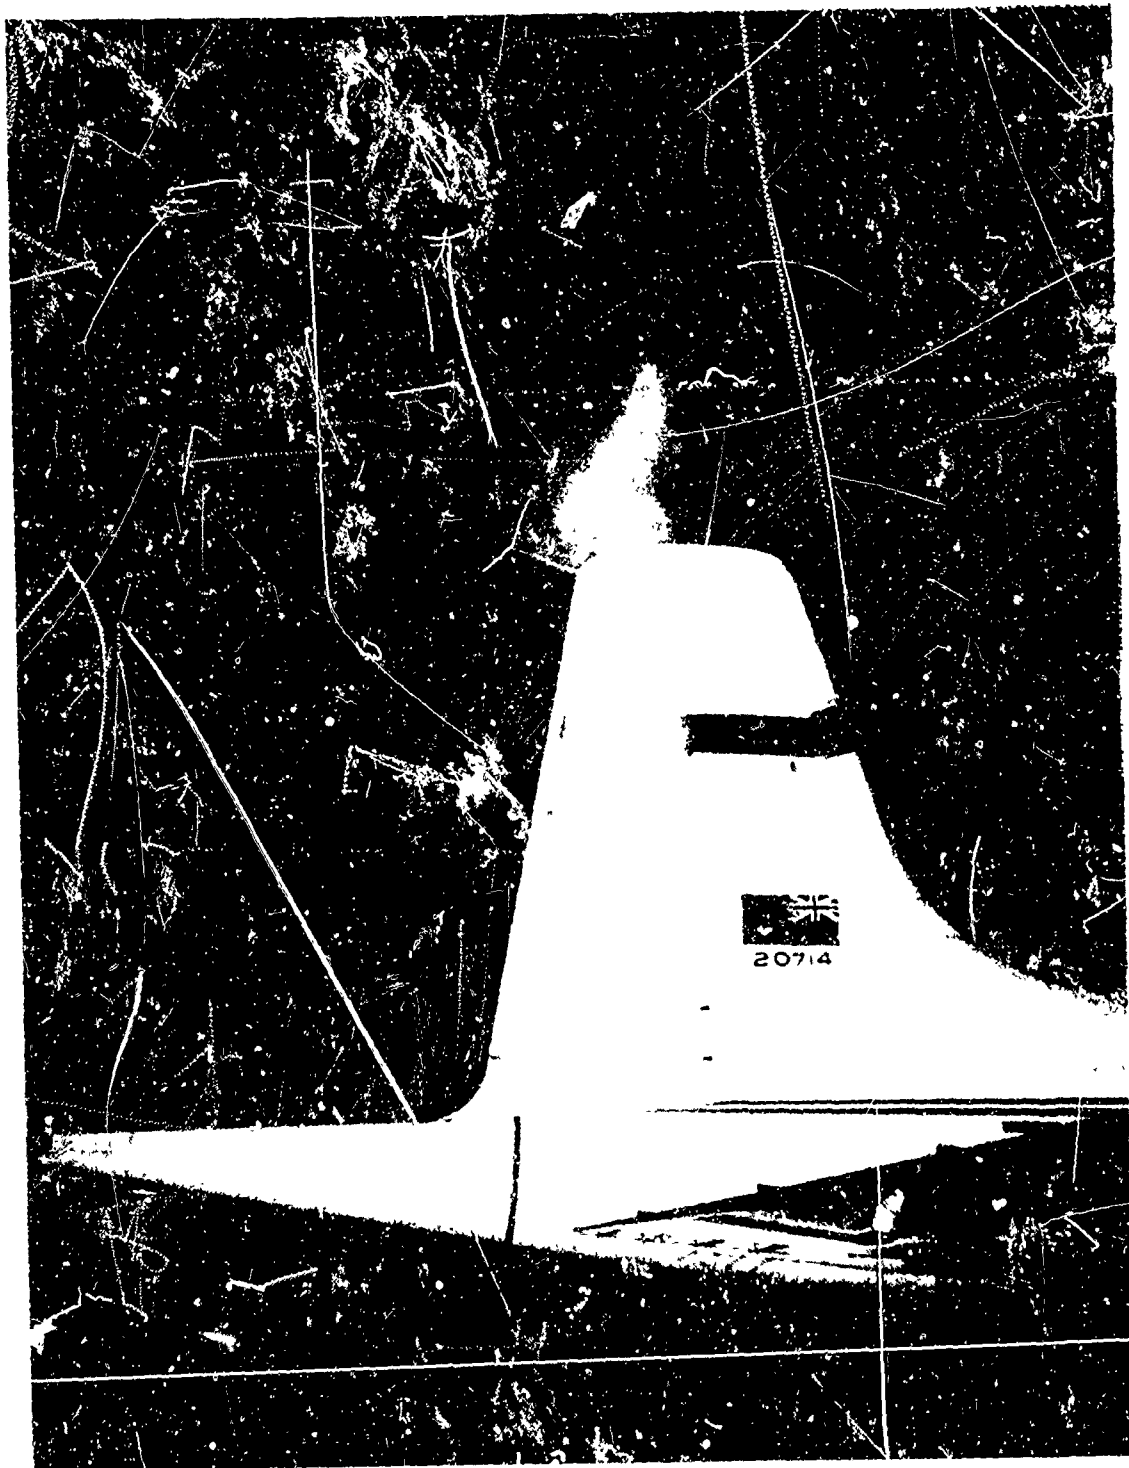
Figure 2. Artificial Lightning Discharge Tests of Graded Resistance Lightning Diverter Rods on Argus Fin Tip

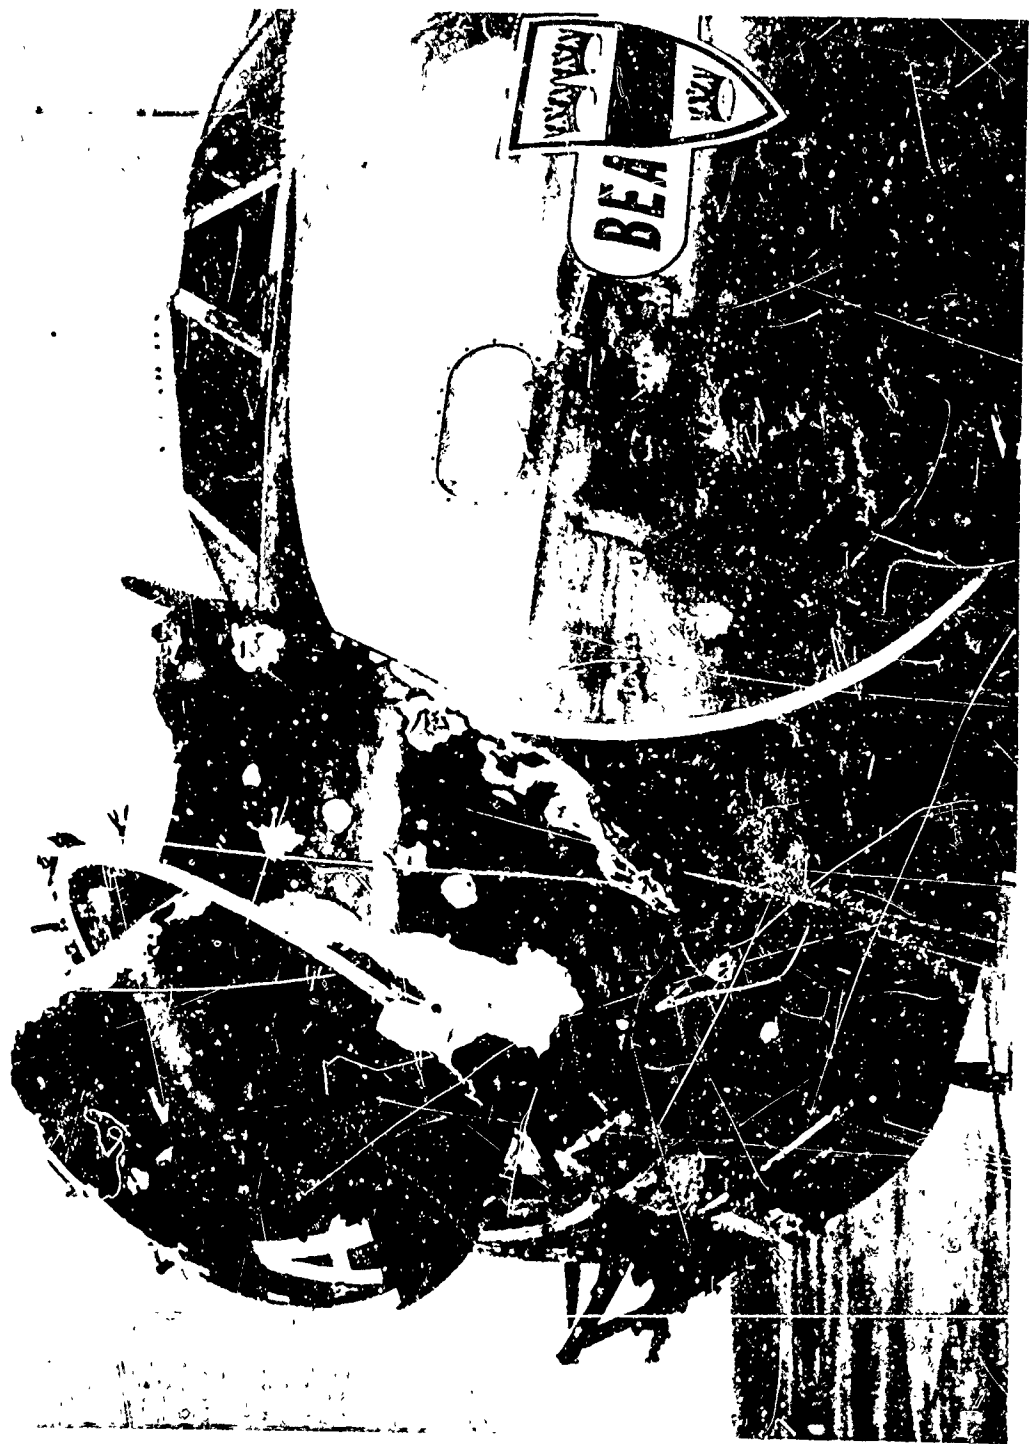
Figure 9. Damage to an Ambassador Aircraft by a Lightning Strike on the Nose Cone
